9300 Henderson Grade
Fort Myers FL 33917-4825
Inspector: Andy Marth
Lic.# HI7980

Property Inspection Report

Client(s): **Jane Smith**
Property address: **123 Main Street**
Anytown, FL 55555 1
Inspection date: **Friday, April 25, 2014**

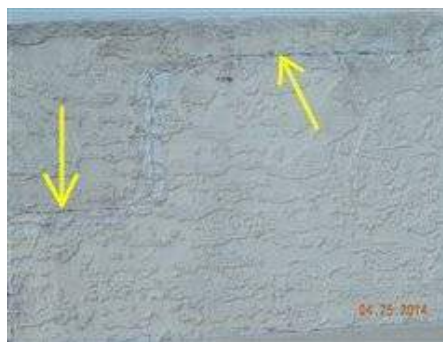
Photo 5-2
Cracks at at mortar lines North wall

Cracks, deterioration and/or damage were found in one or more areas of the exterior stucco finish. In damp climates, moisture can enter cracks or damaged areas and further deteriorate the stucco. Also the wall behind the stucco can become damaged from moisture. Note that areas behind the stucco are inaccessible and excluded from this inspection. Recommend that a qualified contractor repair or replace stucco as necessary.

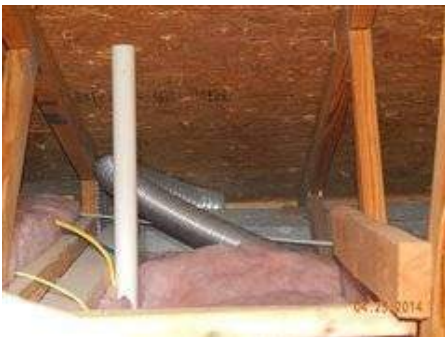
Photo 9-5

One or more exhaust fan ducts terminated at a soffit vent rather than at a dedicated hood or cap. Soffit vents are designed to allow cool air to be drawn into the attic, and to prevent excess moisture from accumulating in the attic. When such ducts are routed to terminate at soffit vents, the moist exhaust air may flow back into the attic and the soffit venting will be reduced. Recommend that a qualified contractor repair per standard building practices. For example, by installing approved hoods or caps at the roof surface or exterior wall(s), and permanently securing exhaust ducts to them.

Bathroom exhaust fan duct terminating at soffit

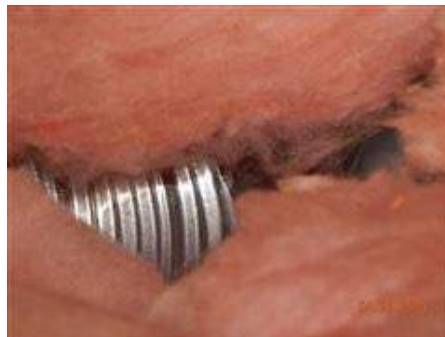
Photo 9-6

Bathroom exhaust fan duct terminating in attic

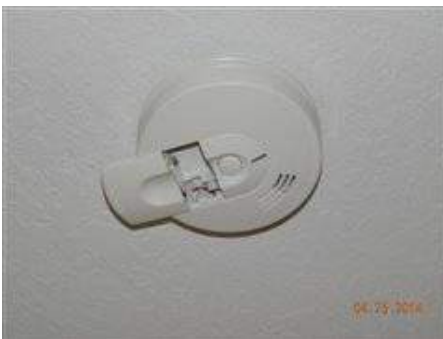
Photo 14-1
No battery in smoke detector

Batteries in all the smoke alarms should be replaced after taking occupancy, and annually in the future. "Chirping" noises emitted from smoke alarms typically indicate that batteries need replacing. For more information, visit:

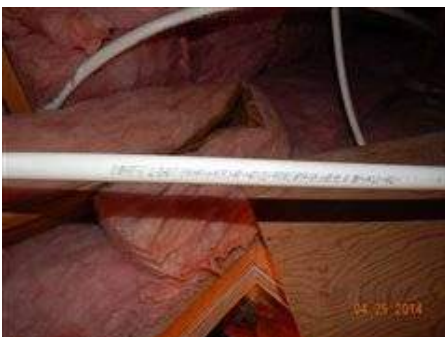
Photo 15-5

Supply piping in attic (PEX)

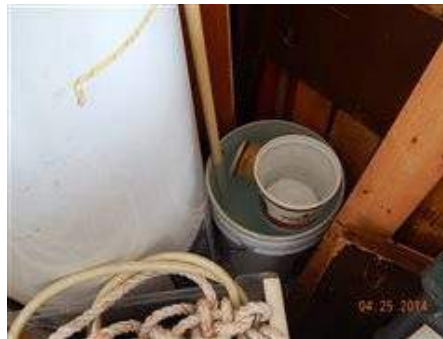
Photo 18-2
TPR drain pipe into bucket

The temperature-pressure relief valve appears to be leaking. A 5 gallon bucket is next to the water heater with the TPR drain pipe in it. And the bucket is full of water. Recommend that a qualified plumber repair as necessary. For example, by replacing the valve.

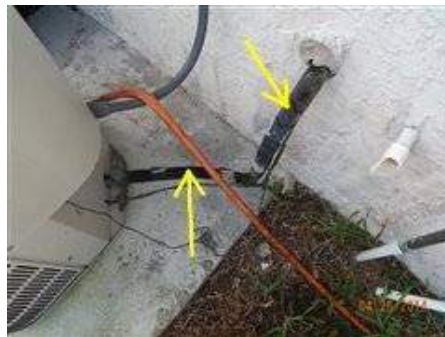
Photo 21-8
Deteriorated insulation

Insulation on the heat pump or air conditioning condensing unit's refrigerant lines was deteriorated or missing in some areas. This may result in reduced efficiency and increased energy costs. Recommend that a qualified person replace or install insulation as necessary.

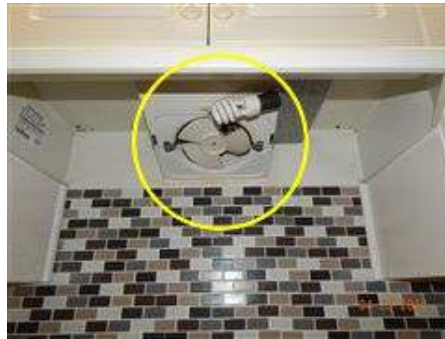
Photo 23-2
Missing filter

One or more filters for the cooktop exhaust fan were missing. Recommend replacing filters as necessary.

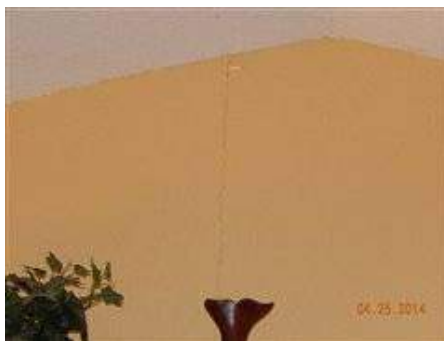
Photo 26-6
Crack in living room wall

25) 🎁 Minor cracks were found in walls and/or ceilings in one or more areas. Cracks and nail pops are common, are often caused by lumber shrinkage or minor settlement, and can be more or less noticeable depending on changes in humidity. They did not appear to be a structural concern, but the client may wish to repair these for aesthetic reasons. For recurring cracks, consider using an elastic crack covering product.
