Wind Mitigation Report

Jane Smith
123 Main Street
Anytown, FL 55555

Andy Marth
HOME INSPECTION SERVICES

Uniform Mitigation Verification Inspection Form

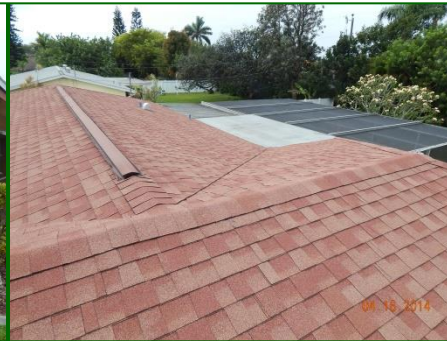
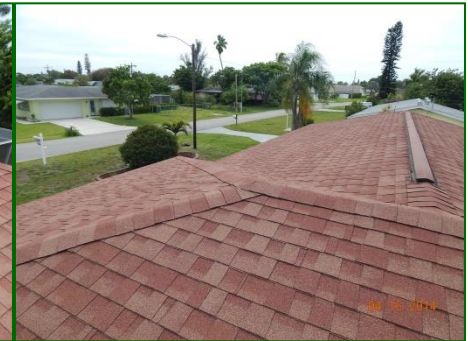
2.1 Roof Covering Type:	Permit Application Date	FBC or MDC Product Approval #	Year of Original Installation or Replacement	No Information Provided for Compliance
<input checked="" type="checkbox"/> 1. Asphalt/Fiberglass Shingle	<u>01/23/2006</u>	_____	_____	<input type="checkbox"/>
<input type="checkbox"/> 2. Concrete/Clay Tile	____/____/____	_____	_____	<input type="checkbox"/>
<input type="checkbox"/> 3. Metal	____/____/____	_____	_____	<input type="checkbox"/>
<input type="checkbox"/> 4. Built Up	____/____/____	_____	_____	<input type="checkbox"/>
<input type="checkbox"/> 5. Membrane	____/____/____	_____	_____	<input type="checkbox"/>
<input type="checkbox"/> 6. Other _____	____/____/____	_____	_____	<input type="checkbox"/>

- ☒ A. All roof coverings listed above meet the FBC with a FBC or Miami-Dade Product Approval listing current at time of installation OR have a roofing permit application date on or after 3/1/02 OR the roof is original and built in 2004 or later.

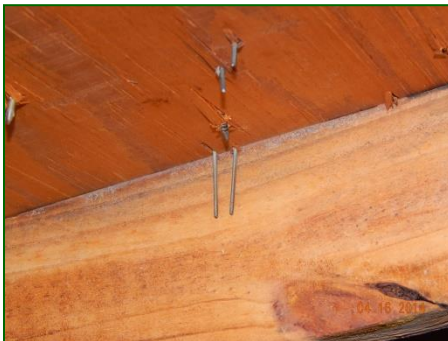
3. **Roof Deck Attachment:** What is the weakest form of roof deck attachment?
 - ☒ A. Plywood/Oriented strand board (OSB) roof sheathing attached to the roof truss/rafter (spaced a maximum of 24" inches o.c.) by staples or 6d nails spaced at 6" along the edge and 12" in the field. -OR- Batten decking supporting wood shakes or wood shingles. -OR- Any system of screws, nails, adhesives, other deck fastening system or truss/rafter spacing that has an equivalent mean uplift less than that required for Options B or C below.

Roof Deck Attachment
Staples

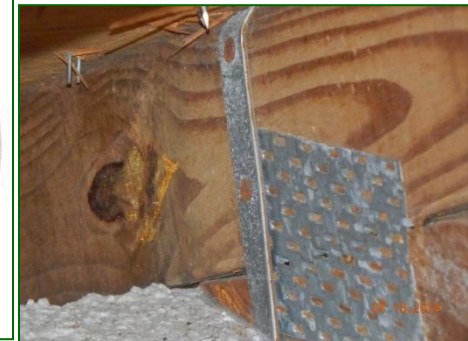
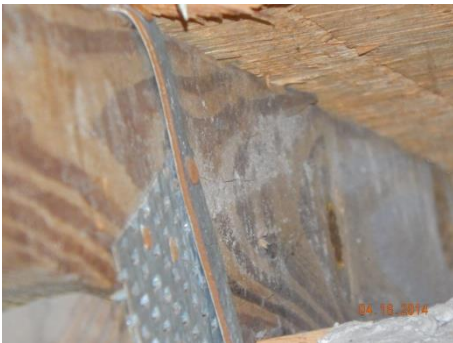
Roof to Wall Attachment

- ☐ A. Toe Nails
 - ☐ Truss/rafter anchored to top plate of wall using nails driven at an angle through the truss/rafter and attached to the top plate of the wall, or
 - ☒ Metal connectors that do not meet the minimal conditions or requirements of B, C, or D

- ☐ Secured to truss/rafter with a minimum of three (3) nails, **and**
- ☒ Attached to the wall top plate of the wall framing, or embedded in the bond beam, with less than a ½" gap from the blocking or truss/rafter **and** blocked no more than 1.5" of the truss/rafter, **and** free of visible severe corrosion.
- ☐ B. Clips
 - ☐ Metal connectors that do not wrap over the top of the truss/rafter, **or**
 - ☐ Metal connectors with a minimum of 1 strap that wraps over the top of the truss/rafter and does not meet the nail position requirements of C or D, but is secured with a minimum of 3 nails.
- ☐ C. Single Wraps

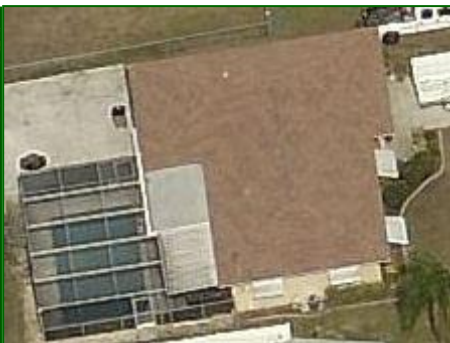
Roof Geometry

- ☒ A. Hip Roof Hip roof with no other roof shapes greater than 10% of the total roof system perimeter.
Total length of non-hip features: _____ feet; Total roof system perimeter: _____ feet
- ☐ B. Flat Roof Roof on a building with 5 or more units where at least 90% of the main roof area has a roof slope of less than 2:12. Roof area with slope less than 2:12 _____ sq ft; Total roof area _____ sq ft
- ☐ C. Other Roof Any roof that does not qualify as either (A) or (B) above.

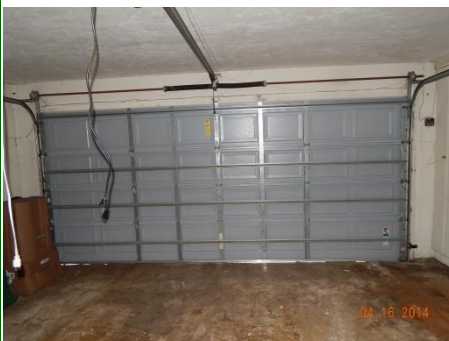
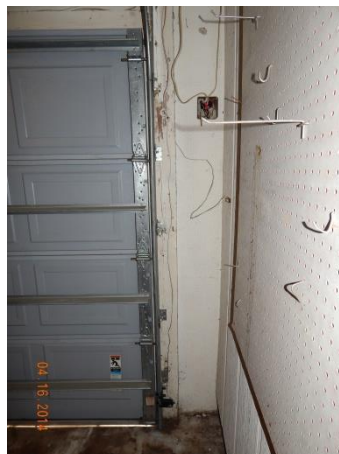
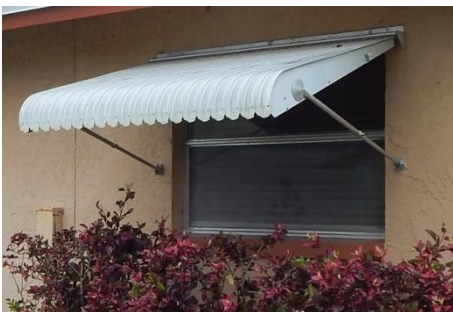
- ☒ **N. Exterior Opening Protection (unverified shutter systems with no documentation)** All Glazed openings are protected with protective coverings not meeting the requirements of Answer "A", "B", or "C" or systems that appear to meet Answer "A" or "B" with no documentation of compliance (Level N in the table above).

- ☐ N.1 All Non-Glazed openings classified as Level A, B, C, or N in the table above, or no Non-Glazed openings exist
- ☐ N.2 One or More Non-Glazed openings classified as Level D in the table above, and no Non-Glazed openings classified as Level X in the table above
- ☒ N.3 One or More Non-Glazed openings is classified as Level X in the table above

- ☒ **X. None or Some Glazed Openings** One or more Glazed openings classified and Level X in the table above.
